**DECOMMISSIONING OF
THE SOUTH BAY MINE
USING
ECOLOGICAL ENGINEERING

1994 FINAL REPORT**

M. Kalin

December 20, 1994

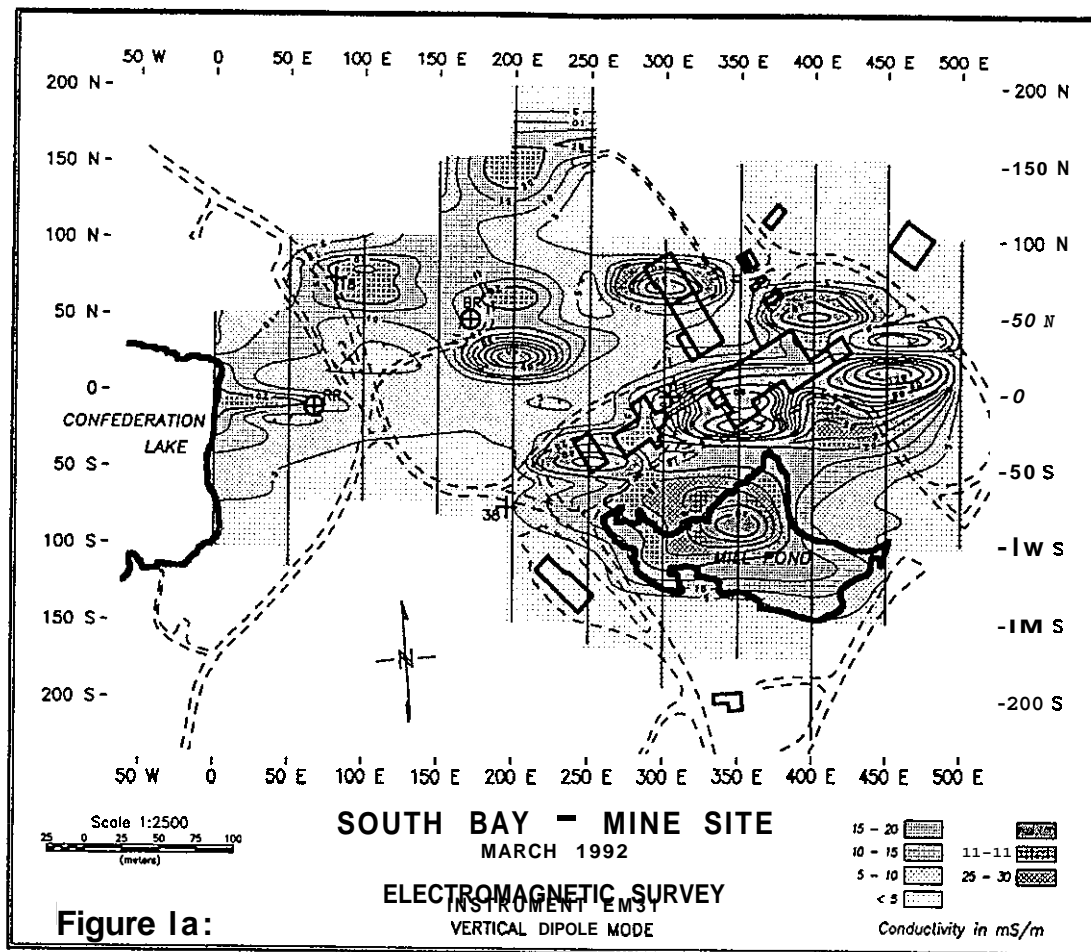
Figure 1a:

The results depicted in Figures 1a, 1d and 1e represent a winter survey conducted in March 1992, when the site was under about 1 m of snow cover. In September 1993, the survey was repeated without the snow cover (Figures 1b and 1c).

Both surveys depicted in Figure 1a and Figure 1b were conducted in the vertical mode to explore to a depth of about 6 m. A large seasonal difference is reflected in the increased conductivities in the immediate area of Mill Pond during the summer months. This is due to an increased water temperature and absence of the snow cover. The other anomalies described previously remained the same.

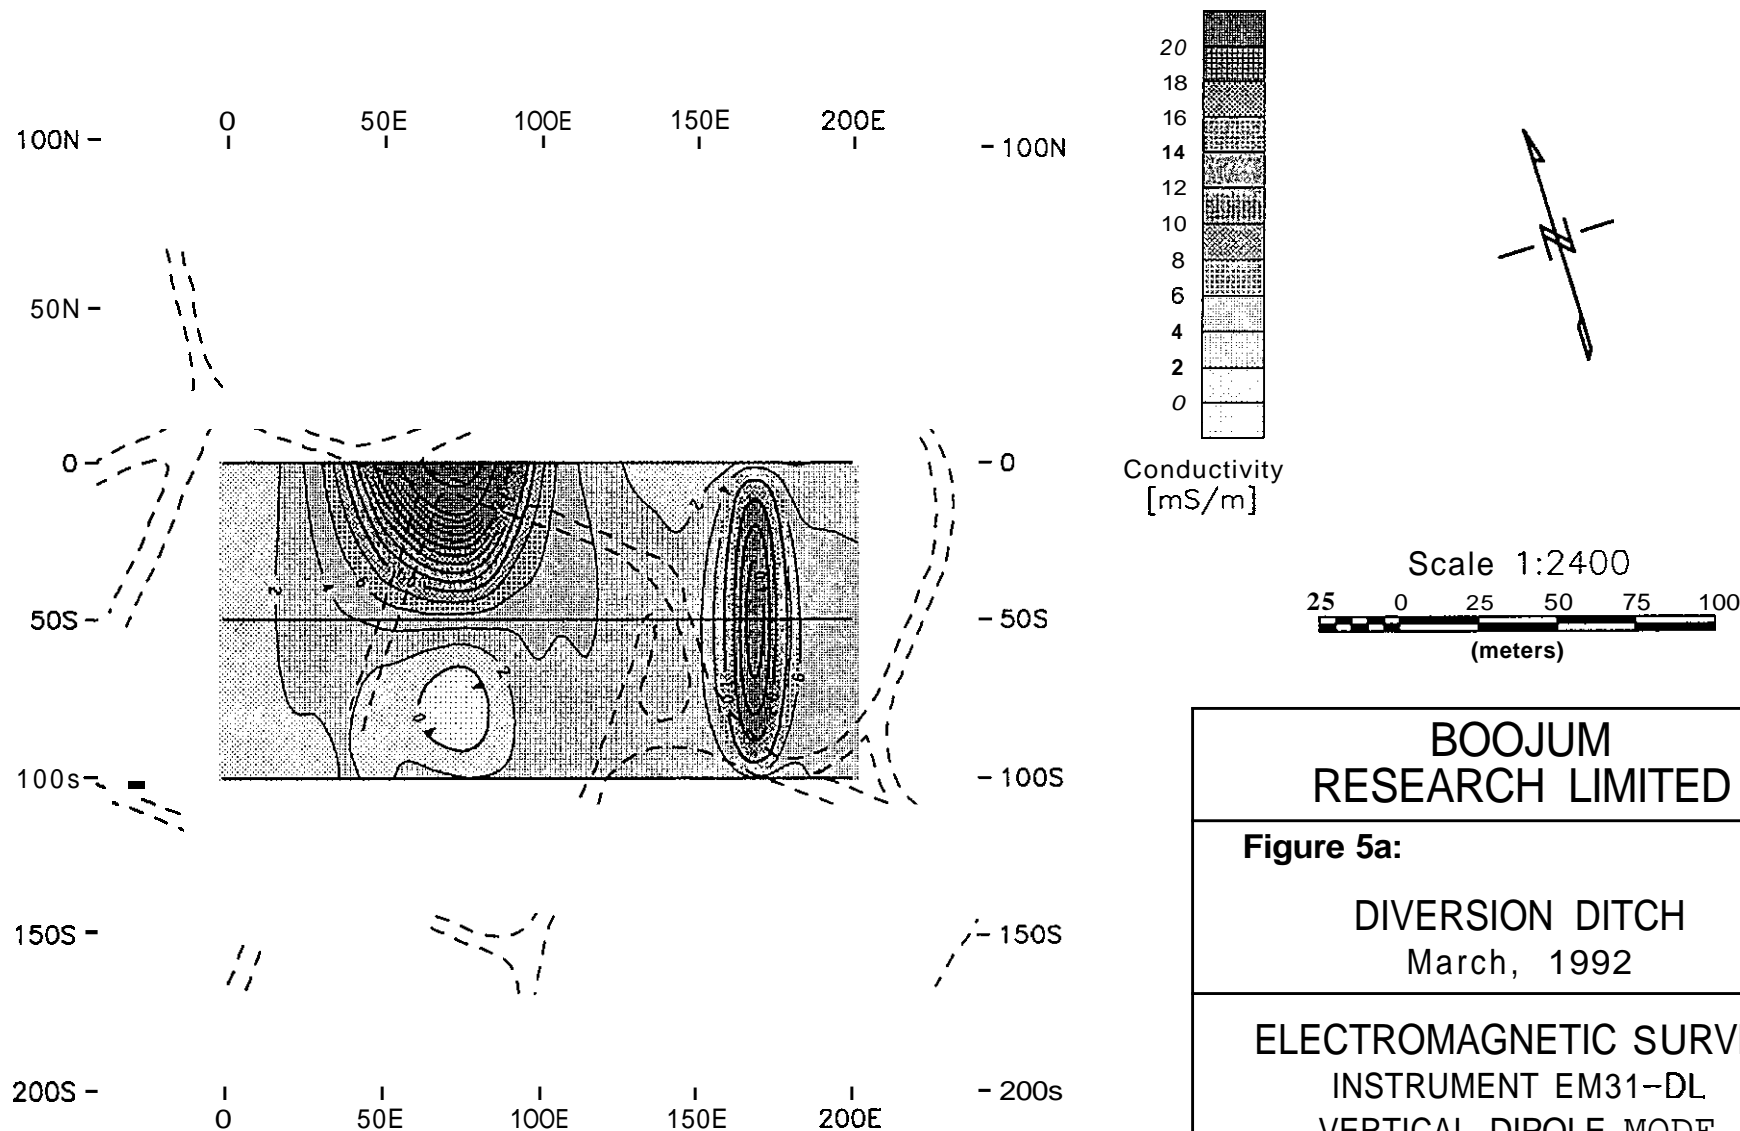
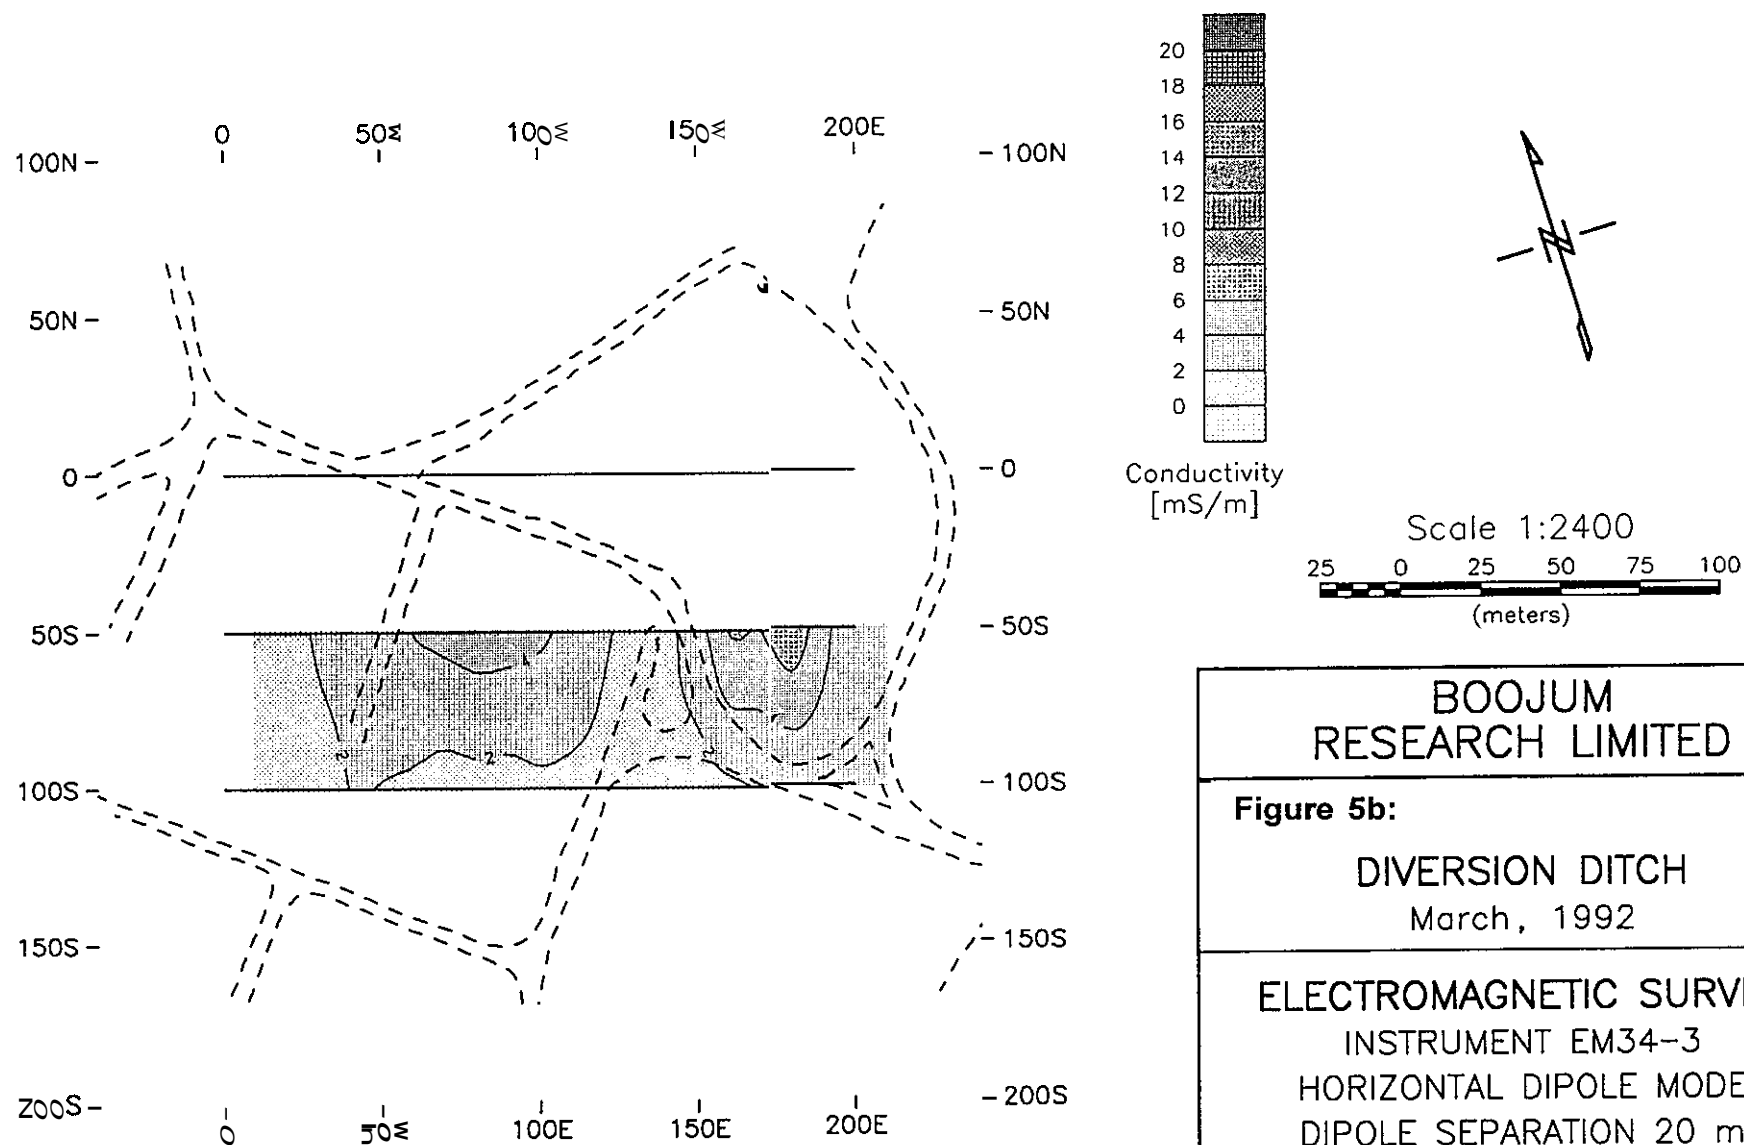
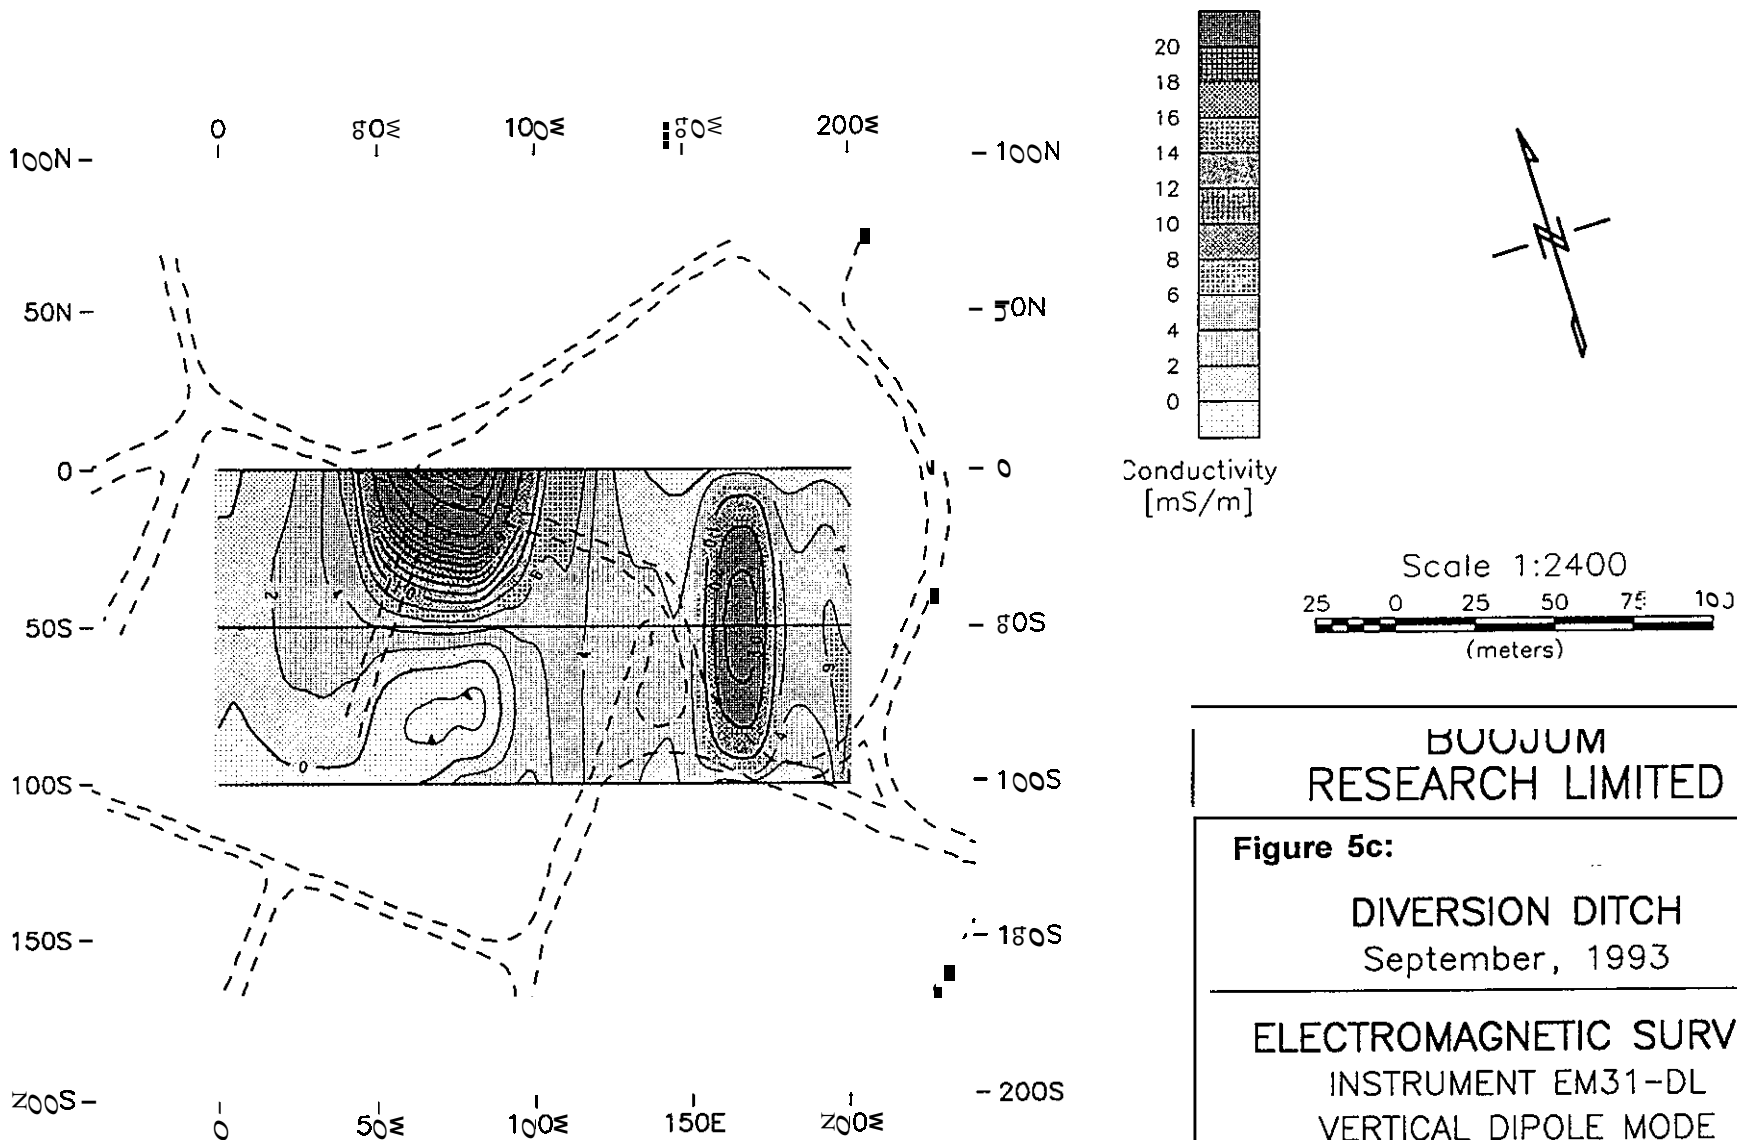
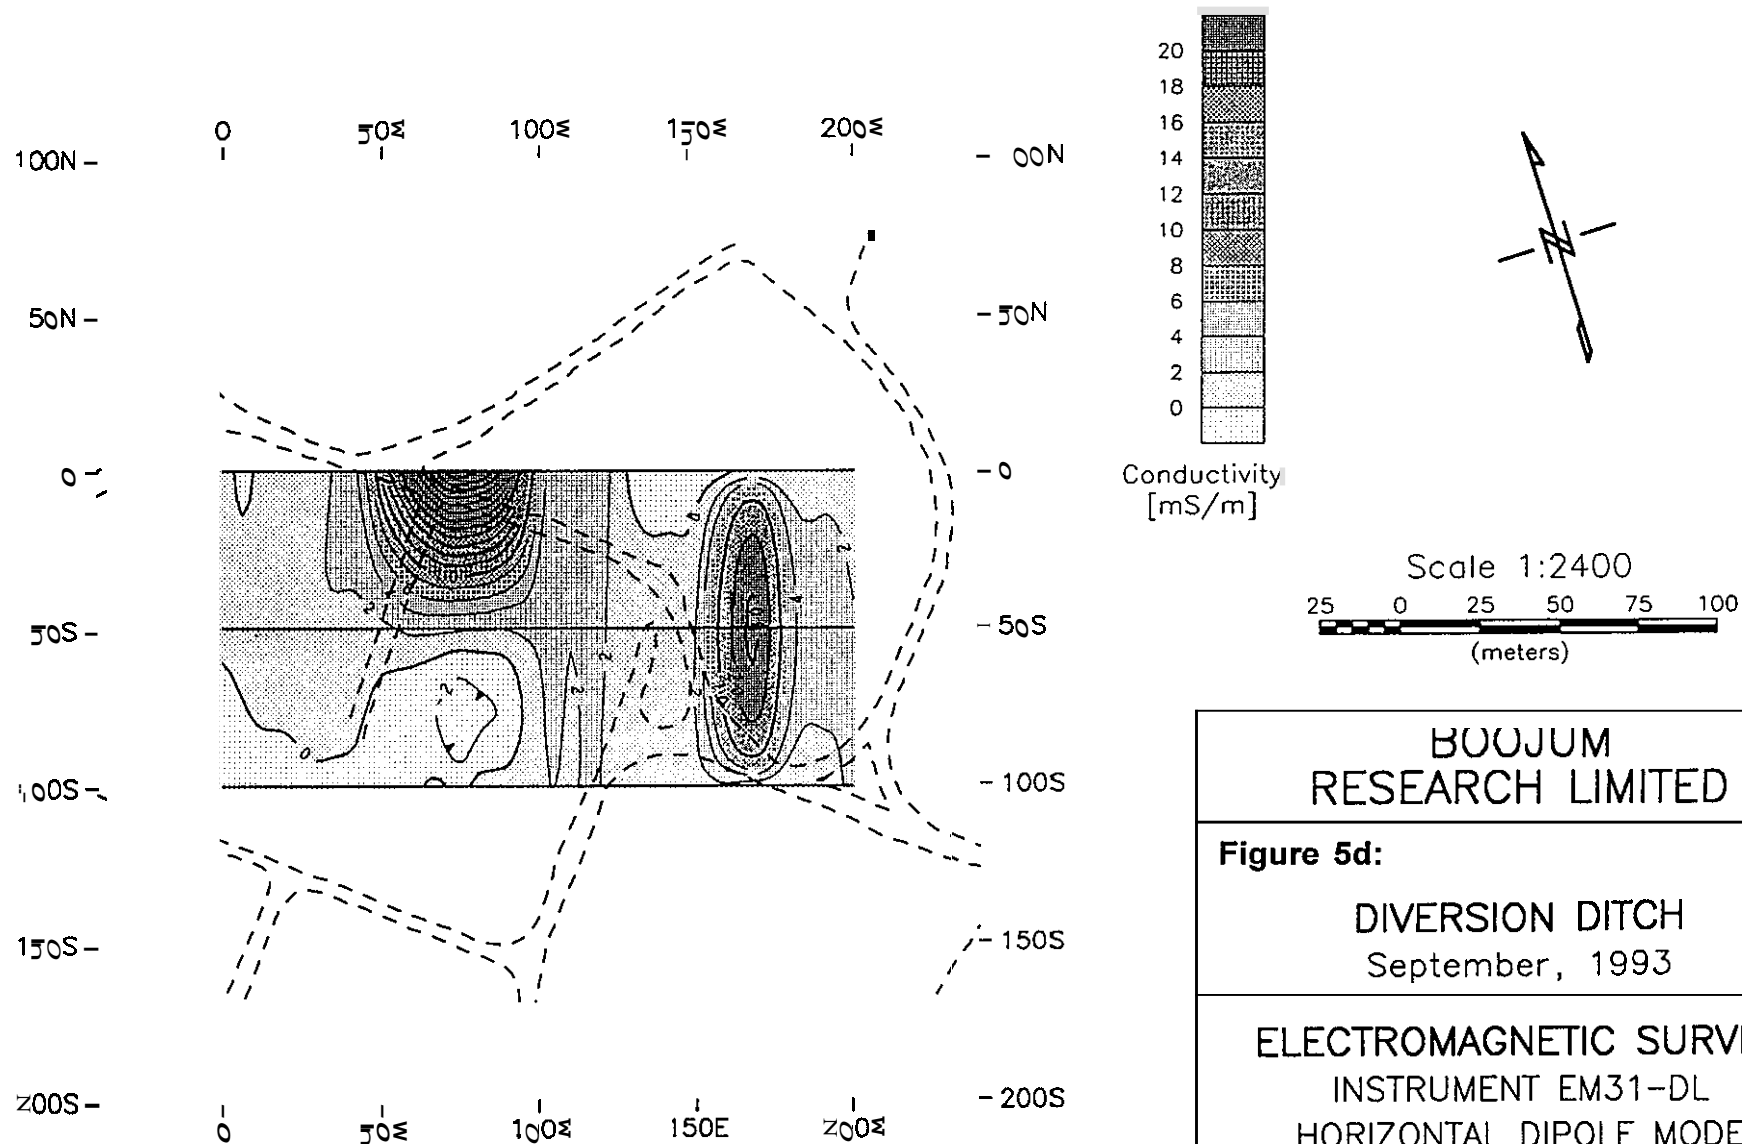
The east anomaly appears to be isolated (Figures 5a-5d), and shallow as the readings become weaker with depth (Figure 5b). This anomaly may reflect residual seepage deposited prior to the construction of the Tailings Diversion Ditch.

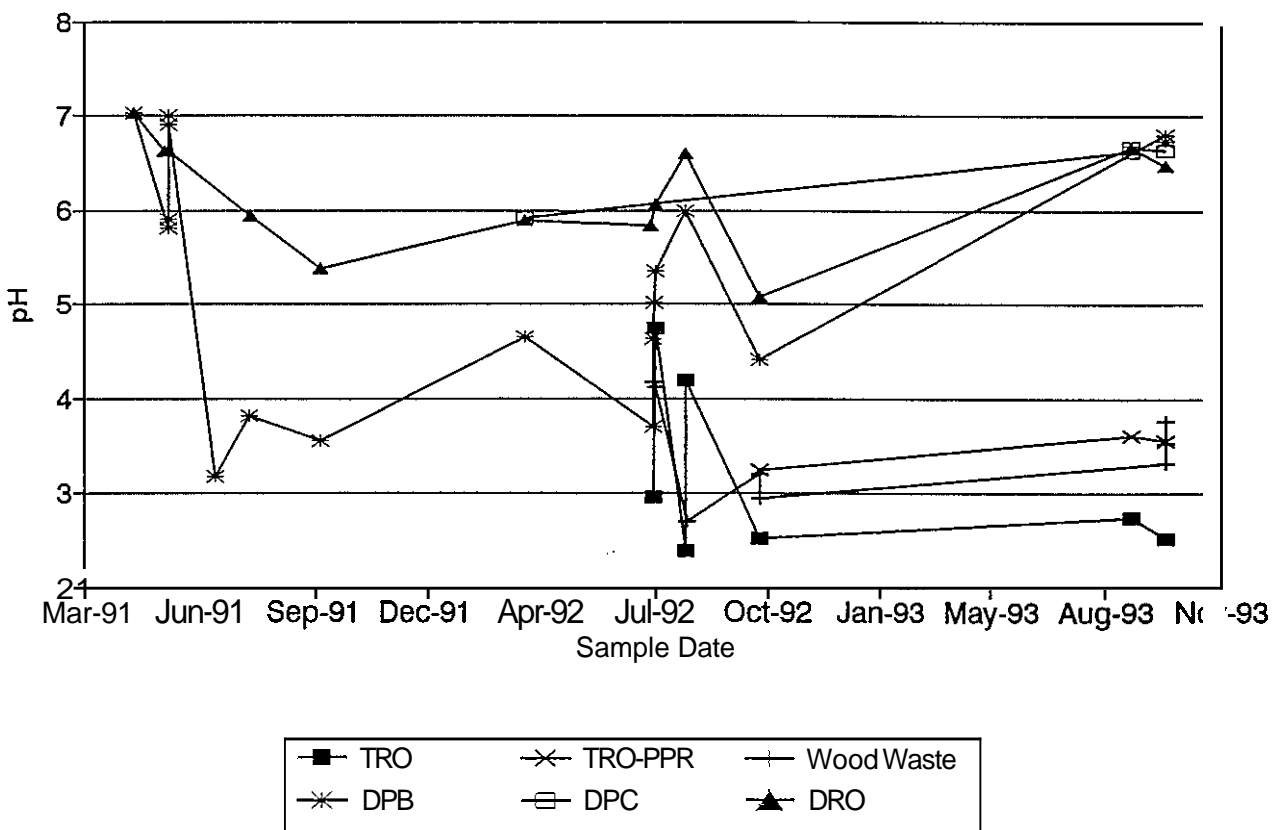
Fig.15: Tailings Run-off-Decant Pond pH
TRO, TRO-PPR, DPB, DPC, DRO

Following application of phosphate rock and wood waste along Decant Pond beach, the pH's of the new Decant Pond beach, centre and outflow became higher (Fig. 15). The zinc concentrations (Fig. 16) and acidity (Fig. 17) have both decreased (note log scale) from the period prior to phosphate rock and wood waste placement. Overall, there is evidence that these remedial actions are serving the objective to counteract the acidification of Decant Pond due to the TRO and the acid generation on the tailings beach. Zinc concentrations in Decant Pond outflow were further reduced to 1.0 mg/L throughout 1994.

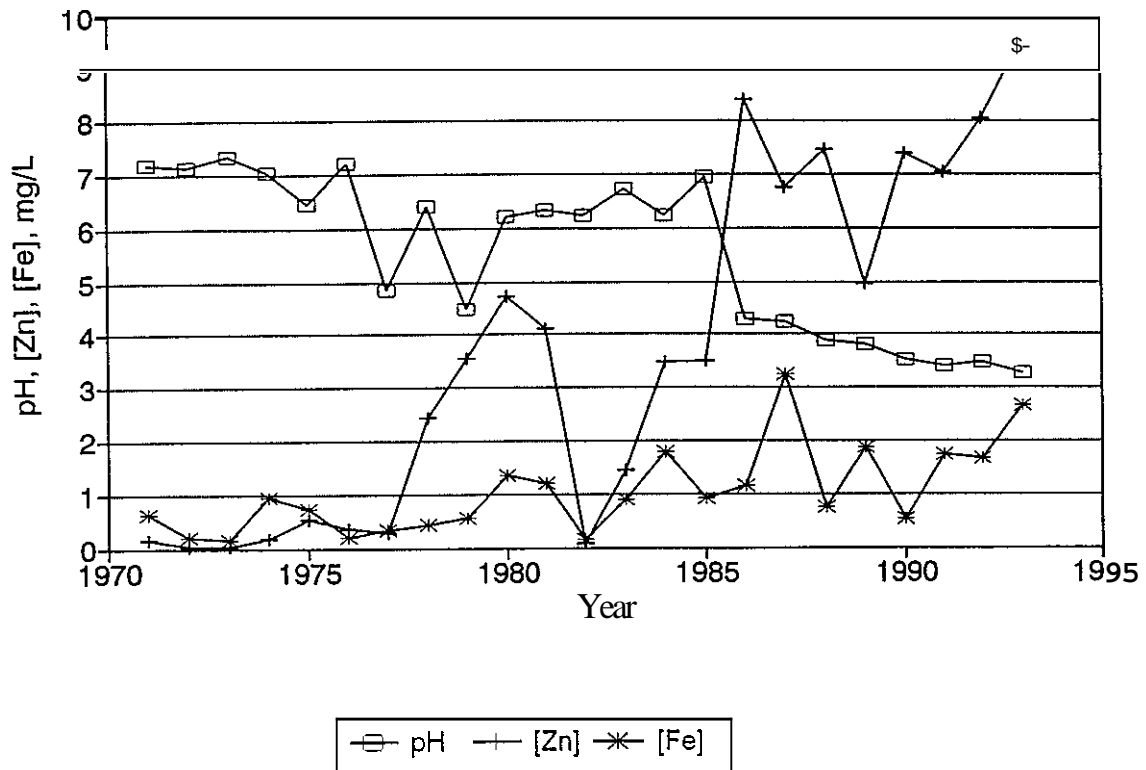
Fig. 18a: Boomerang Lake Annual Average
pH, [Zn] and [Fe]

Decreases in pH and increases in concentrations of iron, zinc, sulphate and acidity in Boomerang Lake between 1971 and 1993 are the result of input of contaminants from sources including the mill and tailings area. These changes are evident in Figure 18a and 18b. During these years, changes in contaminant loadings were offset to some degree by dilution by clean run-off, neutralization and precipitation by lime additions, and by physical/biological processes in Boomerang Lake's water and sediment.

The annual average pH of Boomerang Lake was above 7 between 1971 and 1974, typical for a natural lake in this region. However, the pH was variable and overall lower from 1975 to 1979. The annual average pH was relatively constant between 6 and 7 between 1980 and 1985, probably due to lime addition in Mill Pond, but suddenly dropped in 1986 to pH 4.3. The annual average pH has been steadily declining in the years since. The 1993, the average pH was 3.26.

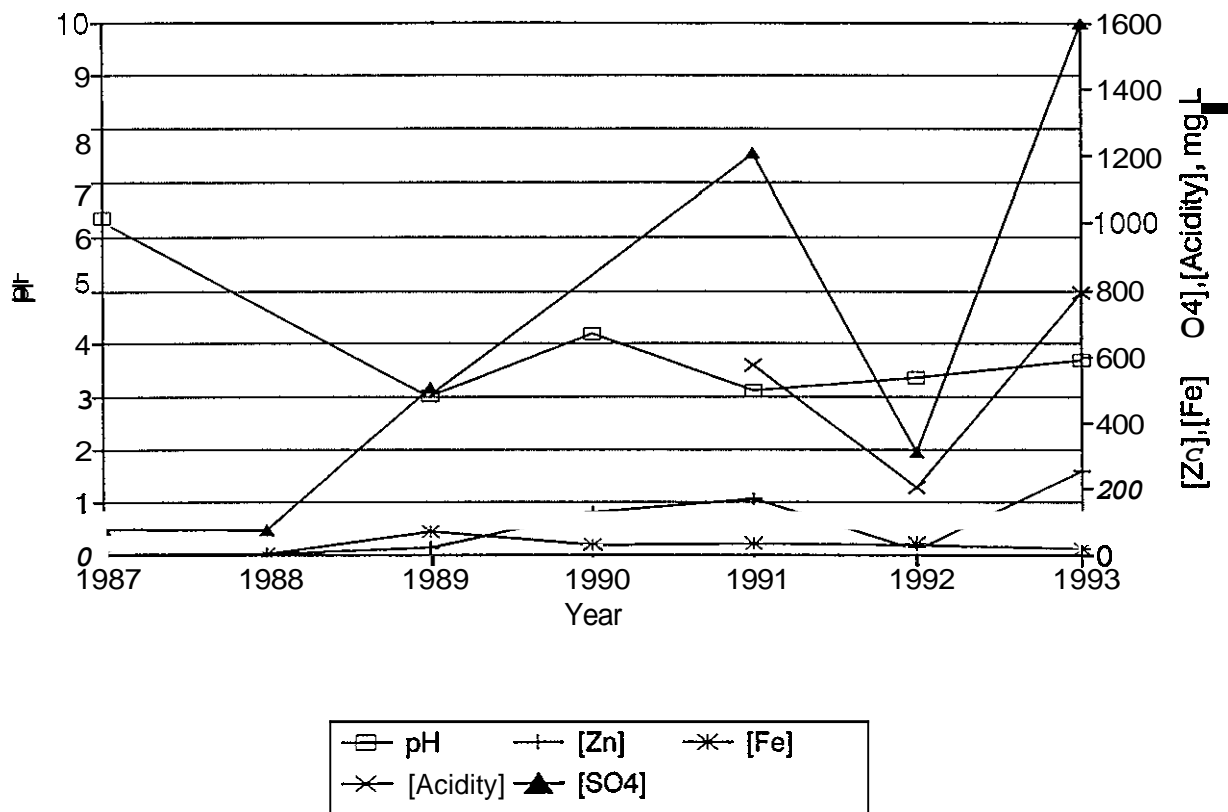
Fig. 20: Backfill Raise Annual Average pH, [Zn],[Fe],[Acidity] and [Sulphate]

Water sampling has been periodically performed since 1987, when the ditch was lowered only slightly to improve flow along the fault line towards Boomerang Lake. These represented sampling stations BR2.5, BR3, BR3.5 and BR4, which have been eliminated due to the construction of the deeper ditch in 1992 (Map 2). Flowing water was usually available for sampling at these stations. Only a few samples were taken each year (1989, 1990) as the water quality was generally acceptable (Figure 20).

Long-term trends in pH and zinc, iron, acidity and sulphate concentrations clearly evident in Figure 20. Since the construction of the deeper ditch in 1992, pronounced contaminant concentration increases are apparent, particularly for sulphate.

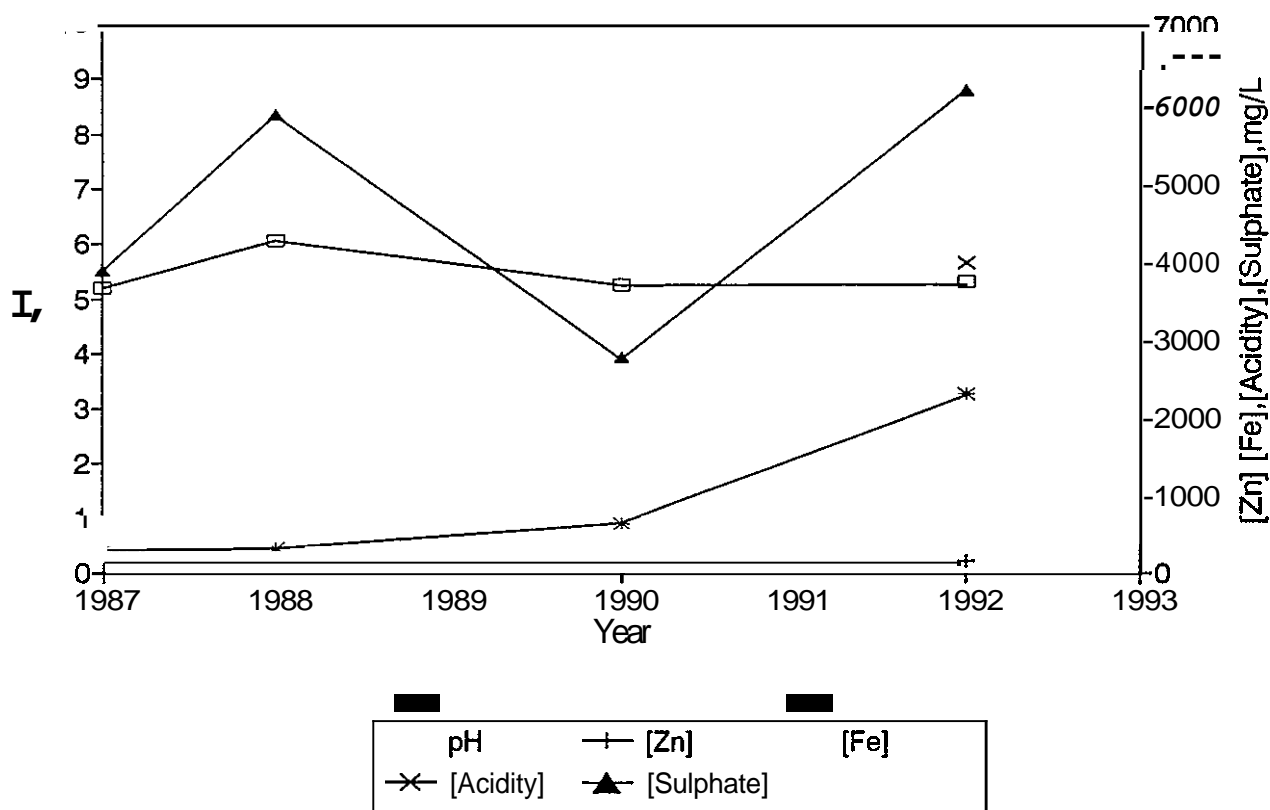
Fig. 22: West Dam M47 Annual Average pH, [Zn],[Fe],[Acidity] and [Sulphate]

Piezometer M47 is situated below the west tailings dam adjacent to Boomerang Lake. Water quality monitoring data for this piezometer in the years 1987, 1988, 1990 and 1992 indicate that groundwater sampled by this piezometer contains high concentrations of zinc (73 to 219 mg/L), iron, 290 to 2300 mg/L) and sulphate (2742 to 6180 mg/L), Figure 22. The acidity measured in 1992 was 3975 mg/L CaCO₃ equiv. Since the pH upon collection is typically 5.2 and higher, iron dissolved in this groundwater is the ferrous oxidation state.

Since this piezometer is located between the dam and Boomerang Lake, the dam must be leaking, and groundwater with the above characteristics is entering Boomerang Lake. While no surface seepages are obviously flowing in this region, upon addition of phosphate rock along this shoreline, precipitates formed and streamed out from the shoreline just below the water level.

The phosphate rock applications carried out in **1992** and **1993** concentrated specifically on these seepage areas. At the outset of the project, and after the grouting, brush was placed in the seepage areas, and prolific algal growth was quantified. In the last two years, algal growth has ceased in these areas. This is a certain indicator that seepage is entering the lake at a higher rate than in previous years. Algae do not grow in water where iron is oxidizing (Kalin and Wheeler **1992**).

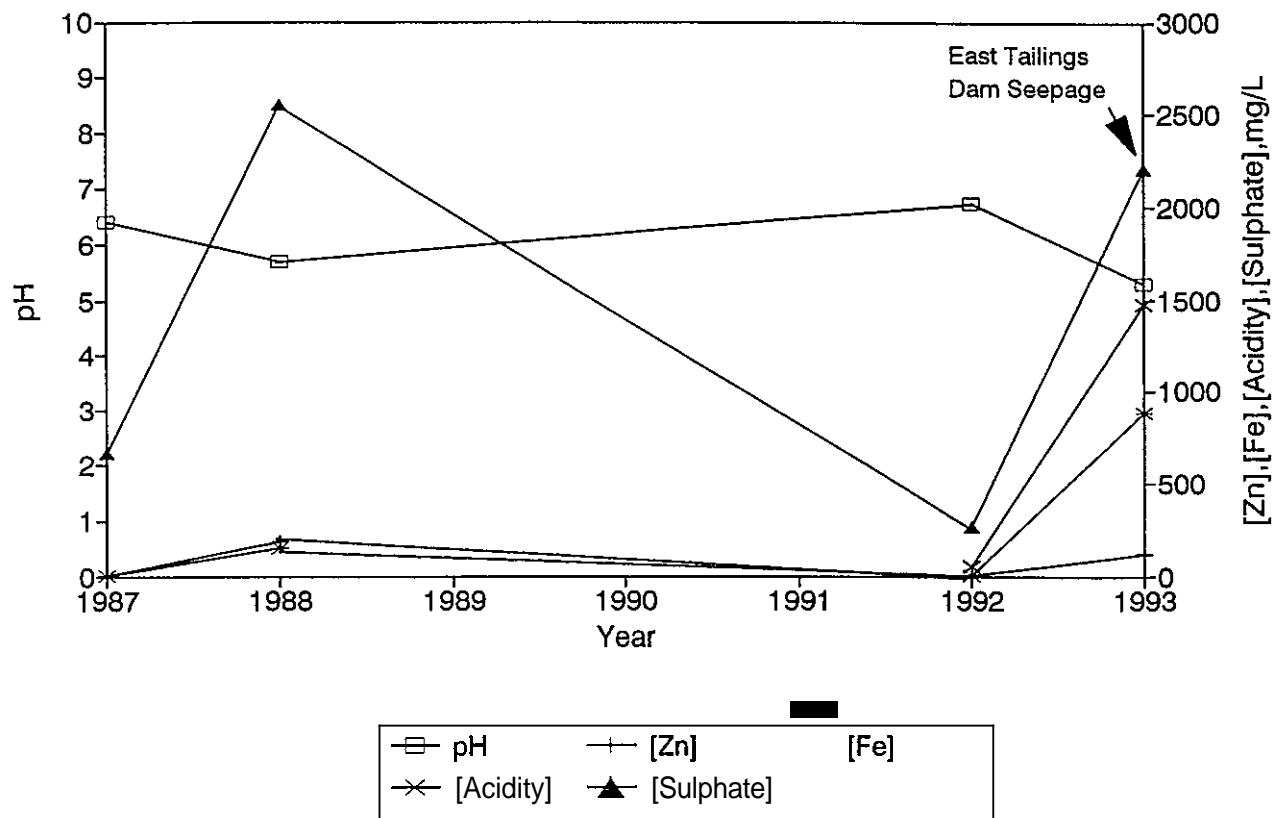
Fig. 23: East Dam M8, M44, Seep Ann Avg
pH, [Zn],[Fe],[Acidity] and [Sulphate]

Seepage of tailings groundwater is entering Boomerang Lake via the east dam in addition to the west dam. In **1993**, a small (**0.01 to 0.04 US /1993**) seepage was observed at the base of the east dam in September and October. This seepage's pH averaged **5.28** at collection, and contained, on average, **118 mg/L** zinc, **885 mg/L** iron and **2204 mg/L** sulphate.

The presence of this seepage confirms earlier suspicions that the tailings groundwater was leaking through the east dam, based on the water quality in piezometers M8 and **M44**, located below the east tailings dam towards Boomerang Lake shoreline (Map **2**). Zinc, iron and sulphate concentrations are as high as **192**, **156** and **2549 mg/L**, respectively (**1988**) in these piezometers (Figure **23**).

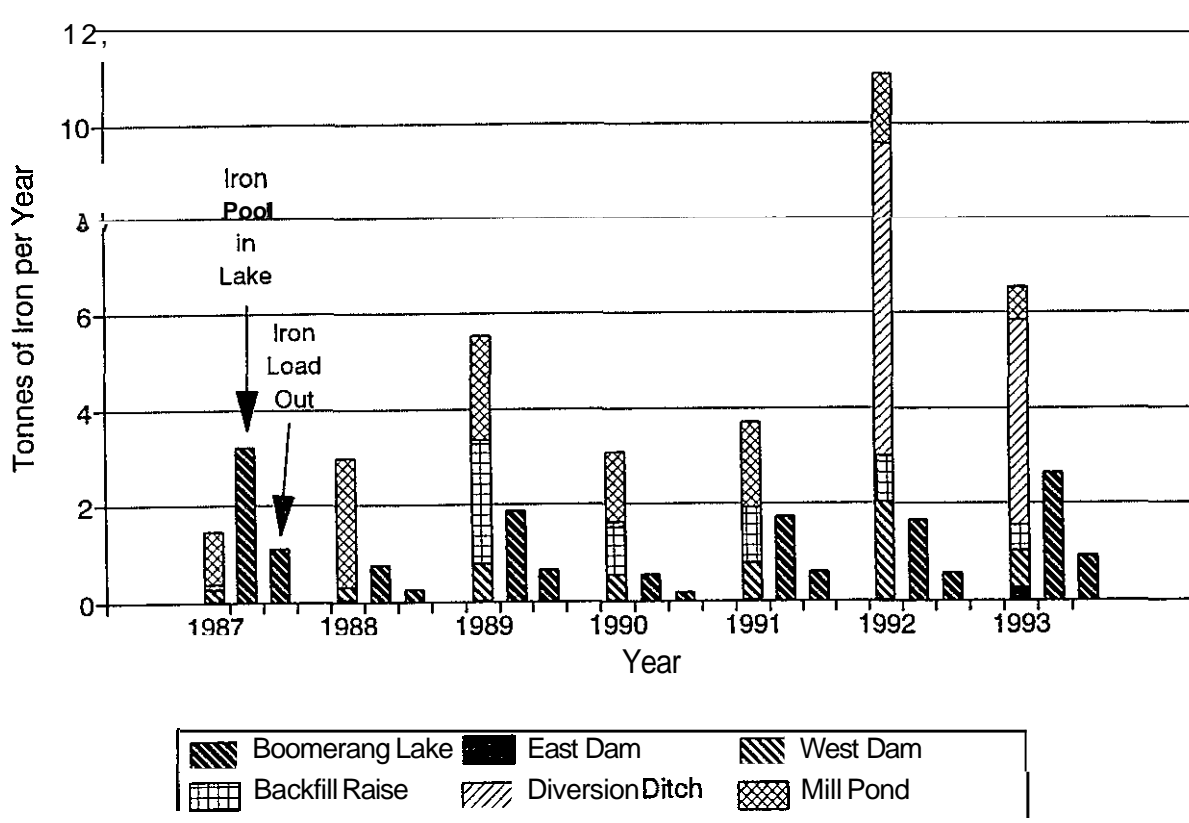
Fig.24: Iron Loadings in Boomerang Lake
Drainage Basin, 1987 to 1993

Iron: For iron (Figure 24), it is clear that a consistently greater quantity is mobilized in the drainage basin each year (3 to 11 t/yr Fe), compared with the amount which leaves Boomerang Lake (1 t/yr or less). This indicates that iron is consistently removed in the sub-drainage basins and in Boomerang Lake prior to discharge. Ferrous iron oxidation, ferric iron precipitation and settling are, very likely, the processes responsible for the observed iron removal.

Mill Pond appears as a major contributor of iron in the years 1987 to 1991. However, higher iron concentrations measured in Backfill Raise ditch in 1989, 1990 and 1991 translated to relatively large contributions of iron from this area as well. In 1992 and 1993, the tailings groundwater diversion ditch was possibly the largest single contributor of iron to Boomerang Lake, based on the greatly elevated iron concentrations determined in samples from the ditch in these years.

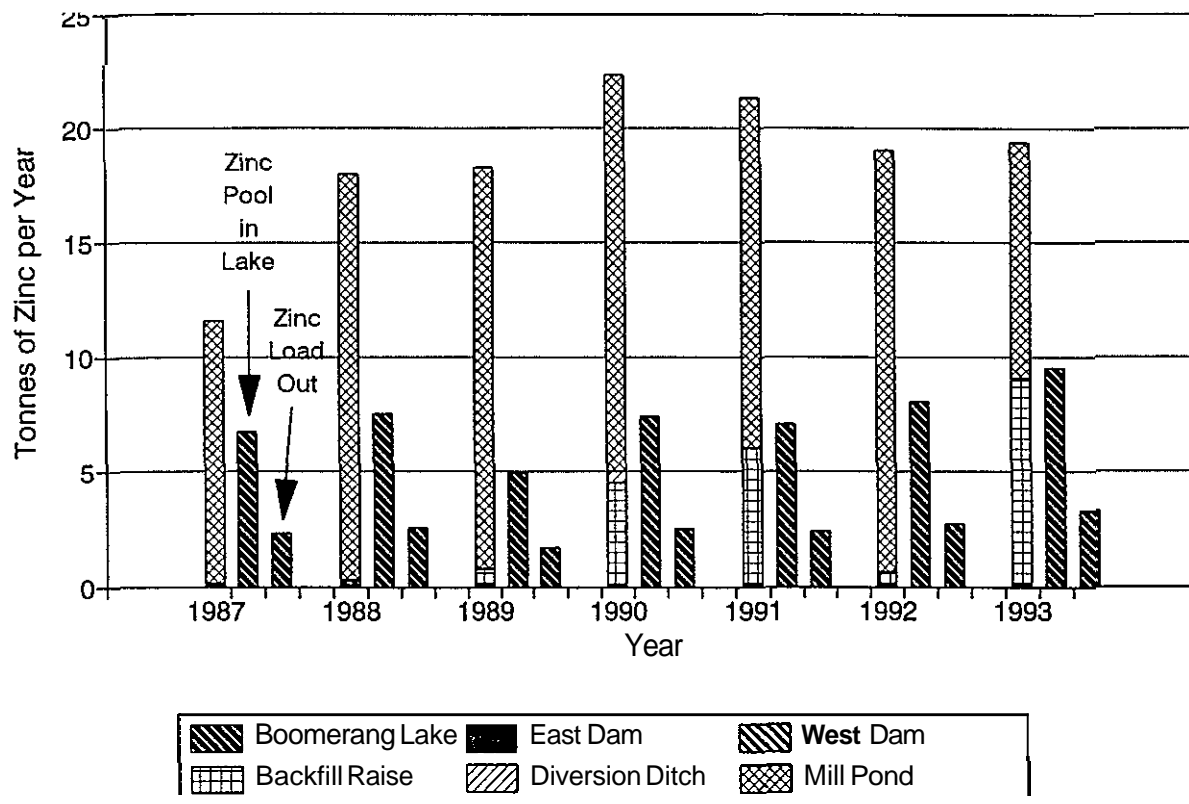
Fig.25: Zinc Loadings in Boomerang Lake
Drainage Basin, 1987 to 1993

Zinc: Between 1987 and 1993, 12 to 23 tonnes of zinc were mobilized each year in the various sub-drainage basins draining to Boomerang Lake (Figure 25). Since far less zinc left Boomerang Lake in its outflow (1.7 to 3.3 ffyr), effective zinc removal mechanisms must be operating in the sub-drainage basins and in Boomerang Lake at large.

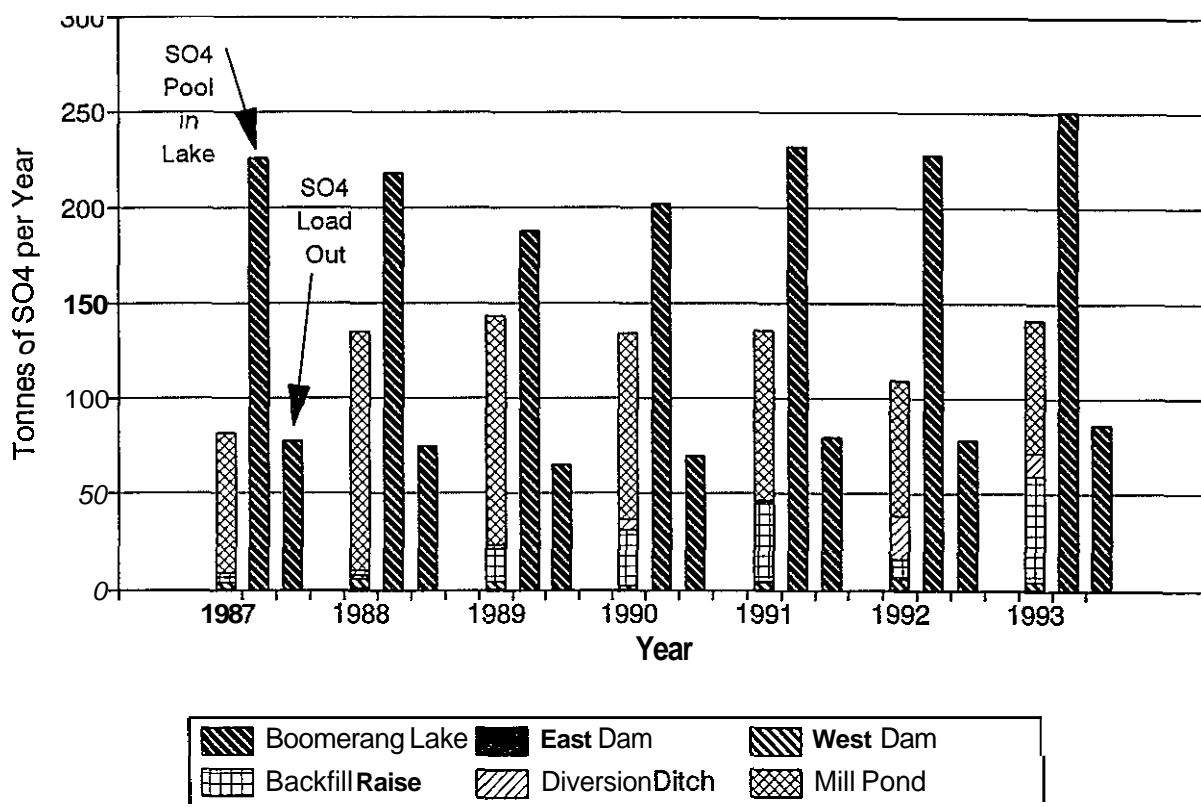
Fig. 26: SO₄ Loadings in Boomerang Lake
Drainage Basin, 1987 to 1993

Sulphate: Between 1987 and 1993, an estimated 82 to 144 t sulphate were mobilized in sub-drainage basins draining to Boomerang Lake. In this same period, 65 to 86 tonnes of sulphate left Boomerang Lake in discharge water each year. Therefore, as observed for iron and zinc, some sulphate removal is likely occurring in the sub-drainage basins and Boomerang Lake prior to Boomerang Lake discharge.
